## EVALUATION OF BIOTECHNICAL CONSOLIDATION OF A WOODED GULLY IN OPOKA DUŻA

Andrzej Mazur

Department for Land Reclamation and Agricultural Structures, University of Life Sciences in Lublin  
Leszczyńskiego str. 7, 20-069 Lublin, amazur70@op.pl

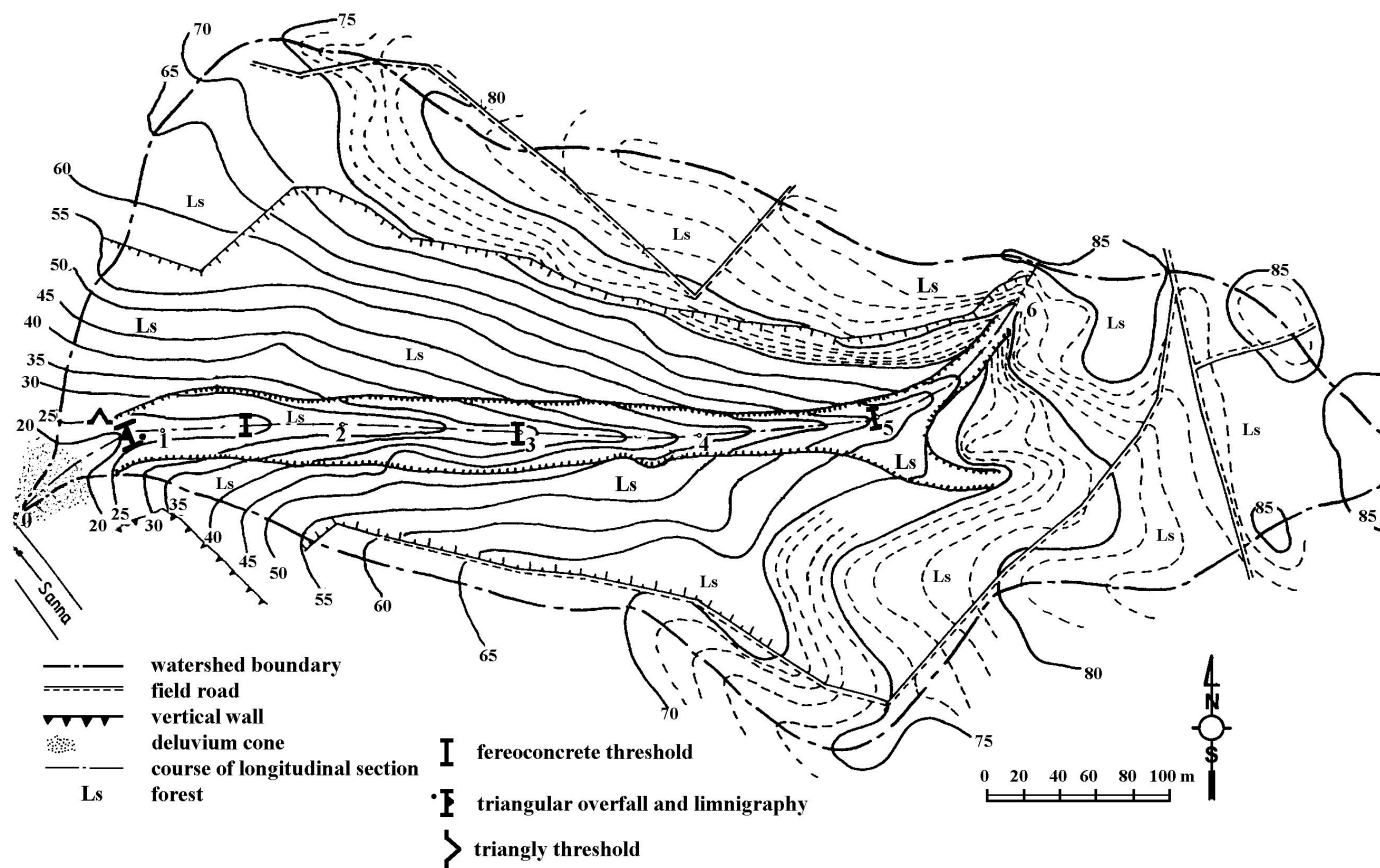
Fig. 1. Altitude scheme of the gully

The studied gully (Fig. 1) has a basin of 14.92 ha area. Its length is about 550 m, depth 12 m and mean width about 35 m. The bottom of the gully is narrow. The mean gully bottom width is 1.4 m and sometimes only 0.6 m. Mean bottom slope is 10.7% and maximum one – 16.7%. In an intersection, the gully is similar to V letter and has mainly steep slopes. The slope inclination at the bottom part of the gully achieves about 80% and at an upper one 30–50%. At the bottom, the slopes are cut and have almost vertical walls about 2.5 m high. At present, almost the whole basin along with the gully is wooded. Wood covers 14.65 ha, which makes 98.2% of the total basin area. The rest (0.27 ha) is occupied by ground roads and sod areas.

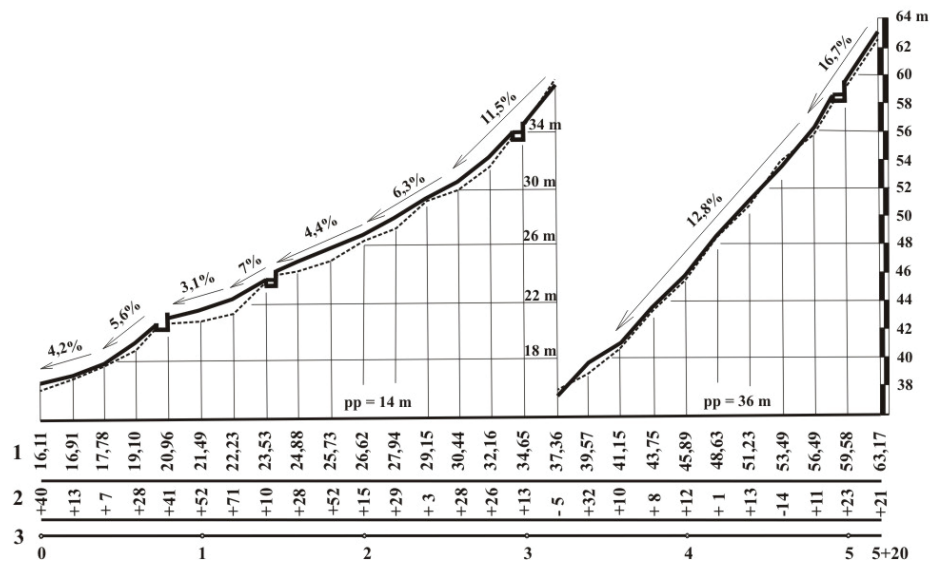
Analysing the results of levelling measurements made in 1970 and 2009 (Fig. 2), it can be found that bottom elevation took place mainly at the lower part of the gully – from hectometre 0 + 82 to 2 + 96, where mean bottom inclination is about 6.5%. The bottom was elevated maximally by 0.71 m. In the upper part, the bottom of mean inclination 13.7% generally did not change – there are visible places where soil material accumulation occurred and places of it washing out. At the bottom of the gully, old erosion thresholds were efficiently fixed and new ones did not appear. All ferroconcrete thresholds and their water pillows are silted up, due to which the height of the erosion thresholds decreased. Only the water pillow of the threshold constructed in the gully outlet is not silted up,

which demonstrates the lack of soil material transport and its effective stabilisation. The deluvial cone that was formed at the gully outlet did not increase its size and was well sodded. The mean thickness of mud deposited at the gully bottom is about 0.21 m. At mean bottom width of about 1.4 m and length of 415 m between extreme ferroconcrete thresholds consolidating erosion thresholds, 123.5 m<sup>3</sup> of soil material accumulated during 39 years at the bottom, including 80% at the lower part of the gully.

Fig. 2. The gully bottom profile: 1 – bottom ordinates in 2009, 2 – silting up (+) and washing out (-) in the period 1970–2009 in cm, 3 – hectometres
