## ROLE AND THREATS OF WATER RESERVOIR IN THE URBAN PALACE AND PARK COMPLEX IN PUŁAWY

**Summary.** The assessment of functioning of small astatic reservoir located in the palace and park complex in Puławy was made in the study. This object is an important element of the urban landscape where it performs both aesthetic and landscape functions. Unfortunately, because of the presence of numerous pollution sources in immediate vicinity, the existence of the reservoir is seriously threatened (including pollution inflow from arable lands and neglected built-up area). Progressive degradation of this water reservoir is observed.

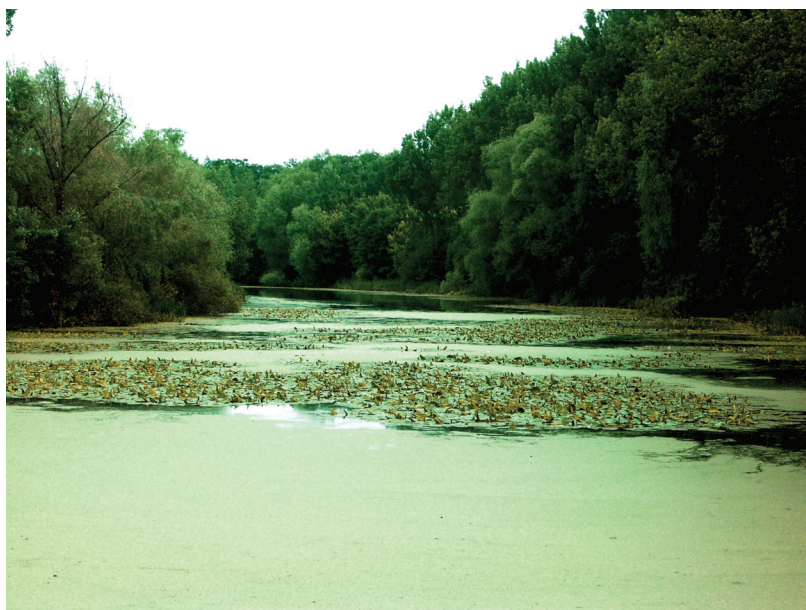
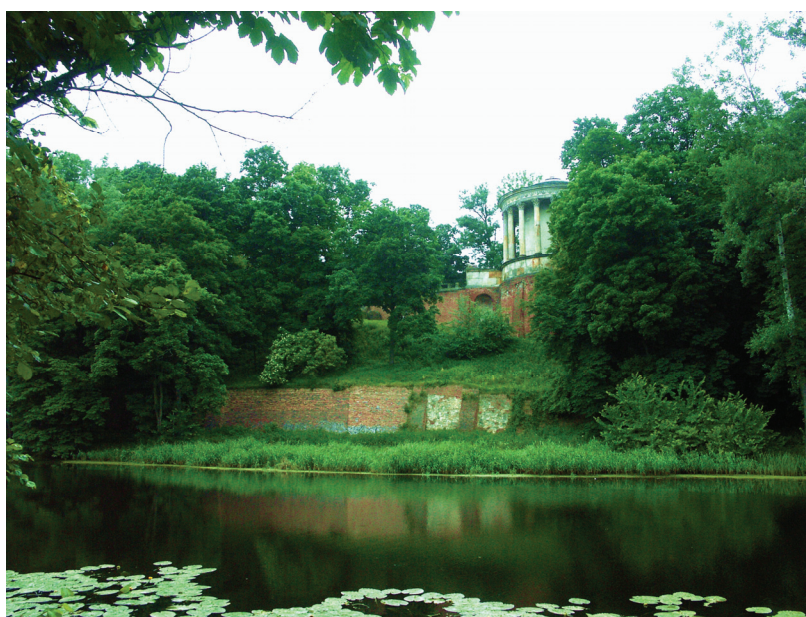
is of 3.1 ha area and 1.2 km length. It is supplied mainly by ground waters. The surface supply occurs only during thawing and intensive rainfalls – namely by means of surface runoffs from the slope adjacent to the reservoir from the east. The palace and park complex of 30 ha area is floristically unique due to the number of species and varieties of trees introduced by Princess Izabela Czartoryska (over 200 years ago). At present, trees in the park consist mainly of small-leaved lime (*Tilia cordata*), pedunculate oak, sessile oak (*Quercus robur et petraea*),

Photo 1, 2. View of the ox-bow lake (June, 2010)

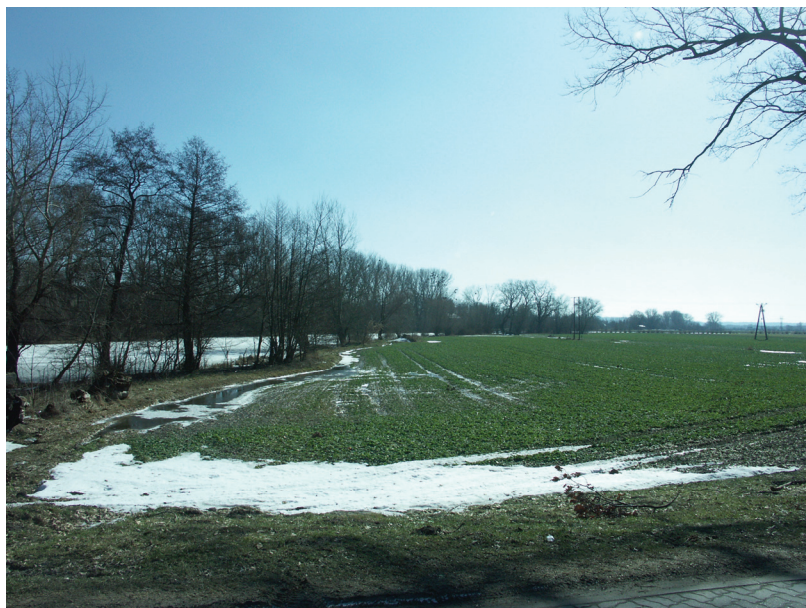
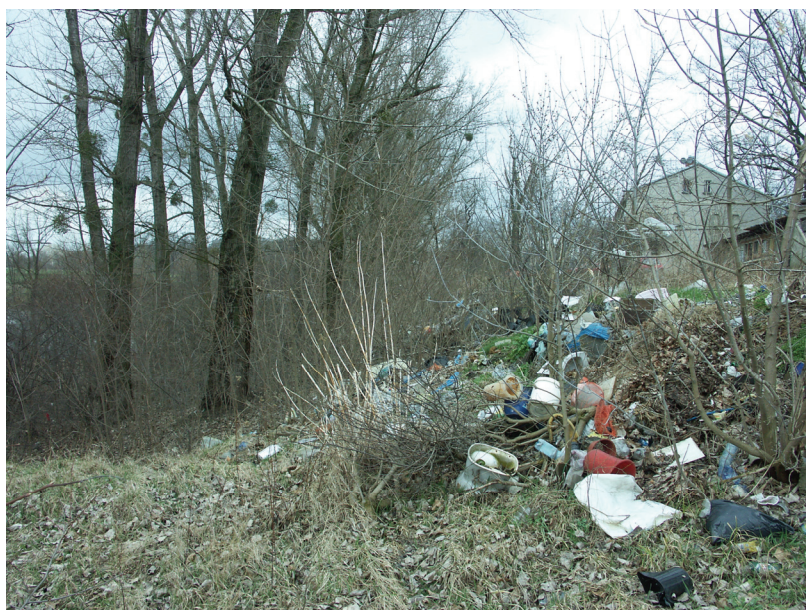
The reservoir existence is seriously threatened – presence of numerous contamination sources in the direct neighbourhood and progressing degradation of the reservoir can be observed. From the west, the oxbow lake borders with a large farm (winter wheat and rapeseed plantations), while the park, shelterbelts, and neglected built-up areas are situated on the east of the studied reservoir. Intensified agricultural production has led to considerable simplification of natural structure of cultivated fields, thus opening the matter cycles. Increasing mineralisation of humus resources and washing out of released minerals is a real threat to the water reservoir [Burt and Haycock 1993, Ekholm *et al.* 2000]. In the case of other areas, sites of illegal waste dumping and leachate drain from there are a significant source of contamination (Photo 3 and 4). A fast outflow of contaminated

Photo 3, 4. Threats to the water reservoir – intensively using of arable land (March, 2010) and places of illegal deposition of municipal wastes (March, 2008)

rainfall and thawing waters toward the reservoir is additionally favoured by large inclination of the slope running along the eastern shore, where it reaches up to 19%.

4. To maintain the oxbow lake in satisfactory condition is possible through making the reclamation operations preceded by elimination of the contamination sources and inhibiting their migration and concentration. Reduction of the supply of contaminated waters and utilisation of the largest possible amounts of biogens at the site of their generation is crucial.
