# INVESTIGATION OF THE WEAR PRODUCTS OF HIGH- NITROGEN STEEL AFTER HYDROGENATION

**Summary.** Assumptions are made about the mechanisms of destruction of these alloys in terms of friction and degradation of the material under the action of hydrogen. The studies wear products of high nitrogen steels.

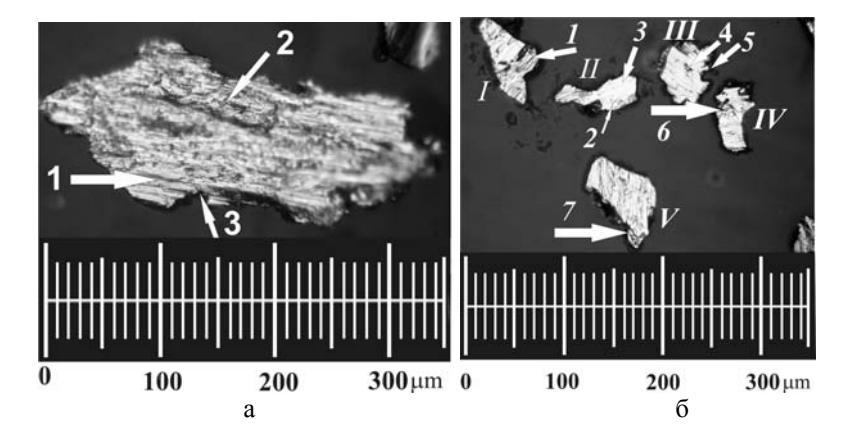
Fig. 1.a Arabic number 1 notes the surface which has a stepped microrelief, 2 - zone subjected to intense heat seizure, 3 - crack in the surface wear particle.

It is show on Fig. 1 b wear particles do not have such intense foci of damage. They are characterized by a stepped microrelief - corresponding to fragile fracture of a particle I, the arrow 1, and the flat surface of a particle III the arrow 4. Assumptions are made about the mechanisms of destruction of these alloys in terms of friction and degradation of the material under the action of hydrogen.

Fig. 1. Wear products: a) after hydrogenation; b) before hydrogenation

Found that hydrogenated steel wear is in 5 times stronger than wear of not hydrogenated. The outward appearance of wear products is quite diverse, which provides evidence of different characters of fracture of the materials under study and, correspondingly, of their different wear rates. Subsequent experiments with these samples (with increasing time after hydrogenation), the wear rate is reduced (probably due to two factors: the running-in of samples and decrease the amount of hydrogen in the surface layer of the alloy). It is stated that the more loading increases, the more size of the wear products increases. For not hydrogenated samples it is  $25...40 \,\mu$ m (load 400 N),  $25...100 \,\mu$ m (load 500 N). For the hydrogenated samples size of particles is  $350 \,\mu$ m (with a load of  $250 \,$ N), 600 microns (load 400 N). The morphology of the wear products is analyzed and described. Noted a significant difference in the appearance of wear particles of hydrogenated and not hydrogenated alloys (Fig1).

The results of tribological tests revealed that the size of the wear products after hydrogenation is much higher than before the hydrogenation of samples (Linear sizes differ in 5 - 6 times) (Fig. 1).

From Fig. 1 shows that after hydrogenation the appearance of the wear products is significantly different from not hydrogenated wear products. Wear products are separated in terms of friction as a rolling and sliding, have significant pockets of seizure and failure rate, compared with the products of wear, which separated from not hydrogenated samples.
