AN EVALUATION OF THE TECHNICAL STATE OF A STARTER USING THE HALL EFFECT - PART II

Summary. The article presents the results of diagnostic investigations into electric starters installed on a real object and an aplication of spectrum analysis of magnetic induction.

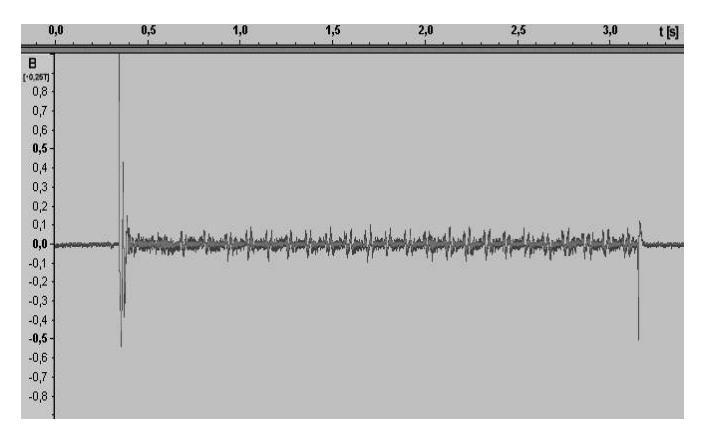
Fig. 1. The course of changes of magnetic induction recorded for an efficient starter fixed in an engine

The mechanical processes in the starter cause an occurrence of electric phenomena around its poles. Due to the recording of magnetic induction in an efficient starter (Fig. 1) it is possible to observe a small alteration of this value. Then, differences in the magnetic induction tensions are caused by higher resistances of the starter's work during the compressing of flammable mixture in the cylinders of combustion engines. During the simulation of damage of sliding muffs and the friction between pole shoes and rotor (Fig. 2), alternating magnetic field's values are observed accompanied by an alternating consumption of the current from battery.

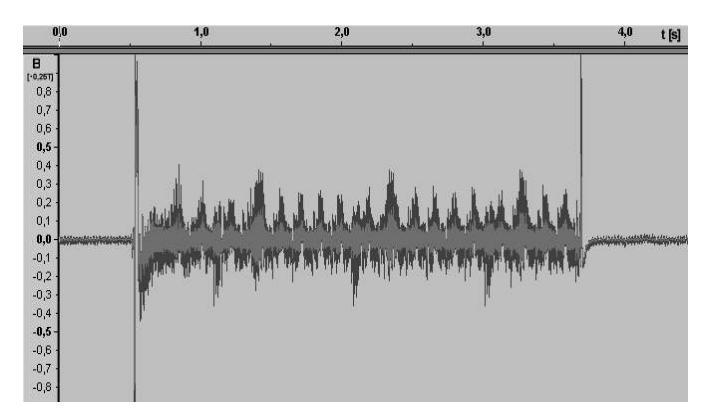
Fig. 2. The course of changes of magnetic induction recorded for a starter with simulated damage of sliding muffs fixed in an engine

They also change the interaction between the magnetic fields of stator and rotor which results in an increase of the current's consumption from battery. As a result, an alternating magnetic induction occurs. Similar magnetic induction parameters can be observed during the simulation of damage of brushes and commutator's starter (Fig. 3-4). It results from arising disturbances in the winding at commutator's stuttering and faulty adherence of brushes to commutator (when the commutator is damaged), as well as in the case of periodical lack of brushes-commutator adherence, which is shown in Fig. 4.

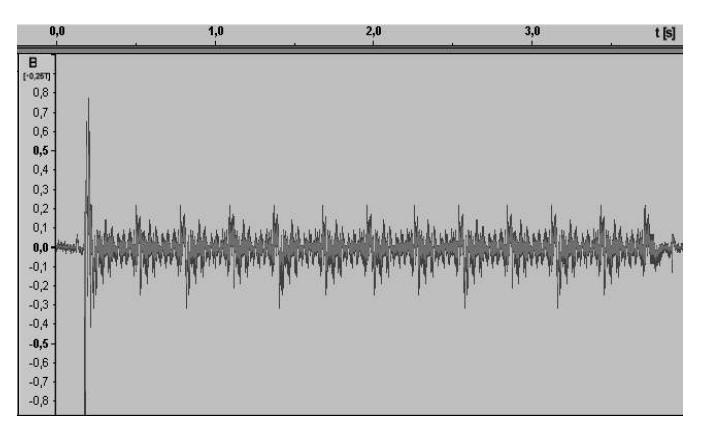
Fig. 3. The course of changes of magnetic induction recorded for a starter with simulated damage of commutator fixed in an engine

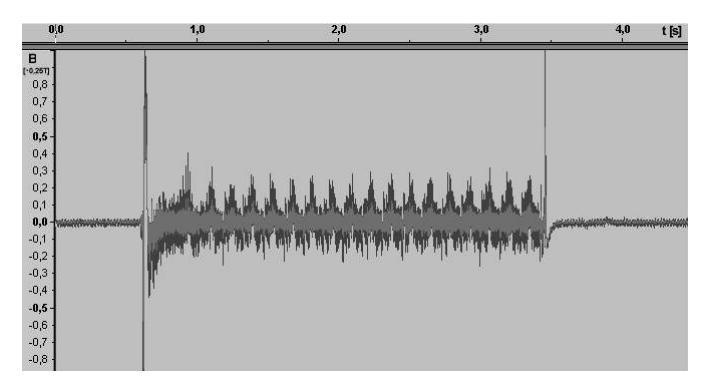
Fig. 4. The course of changes of magnetic induction recorded for a starter with simulated damage of brushes fixed in an engine

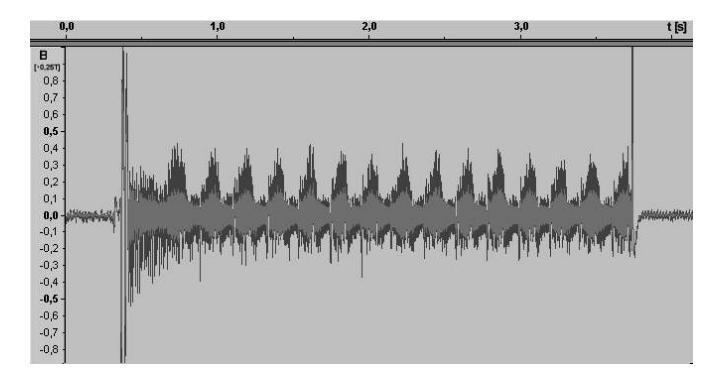
Fig. 5. The course of changes of magnetic induction recorded for a starter with simultaneous occurrence of all the mentioned damages fixed in an engine

Fig. 5 presents the course of changes of magnetic induction recorded for a starter with simulated simultaneous occurrence of all the mentioned electromechanical damages. The course of magnetioc induction is similar to the one recorded for an efficient starter, however, the difference is that the intensity of this induction is considerably higher with all the damages occurring simultaneously than with an efficient electromechanical system of a starter.
